US Army Corps
of Engineers
Waterways Experiment
Station

Technical Note ZMR-1-18

Zebra Mussel Infestation at Black Rock Lock, Buffalo, New York

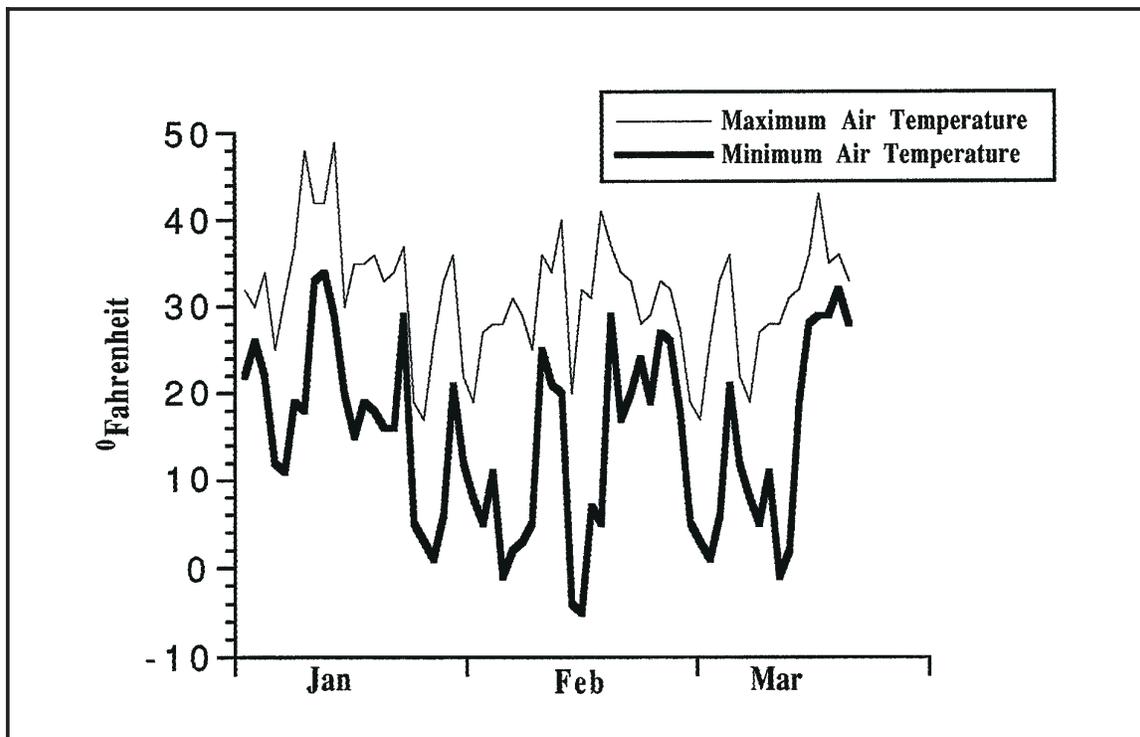
Freeze kill Pumpouts at the Black Rock Lock take place in the winter when there is ice in the channel and on Lake Erie (Figure 1). This provides for a natural freeze kill, although varying temperature conditions throughout the lock affect the amount of time required to completely kill exposed mussels. In 1993 the lock had been pumped out for 8 weeks and some areas still contained live mussels. The most rapid kills were in areas exposed to direct air temperature and sunlight, no moisture, with only a single layer of mussels. In these areas, dead mussels were observed in 3 days; within 5 days, shells were completely open and most of the tissue had deteriorated. Layers of mussels 2 in. deep or thicker required 3 to 4 weeks for a complete kill. In protected areas with high moisture, some mussels were not killed during the pumpout period. Mussels stayed alive for 6 weeks in the culvert, which was moist and protected from extreme low temperature. A layer of snow or ice appeared to protect thick layers of zebra mussels.

Figure 1. Maximum and minimum air temperatures, January-March 1992, at Black Rock Lock, New York. [To obtain Celsius (C) temperature readings from Fahrenheit (F) readings, use the following formula: $C = (5/9) (F - 32)$]
